National Register of Historic Places Registration Form

Historic name U.S. Inspection Station—Beebe Plain, Vermont
Other names/site number Beebe Plain Inspection Station; Beebe Plain Border Station

*U.S. Inspection Station—Beebe Plain
Orleans County, Vermont*

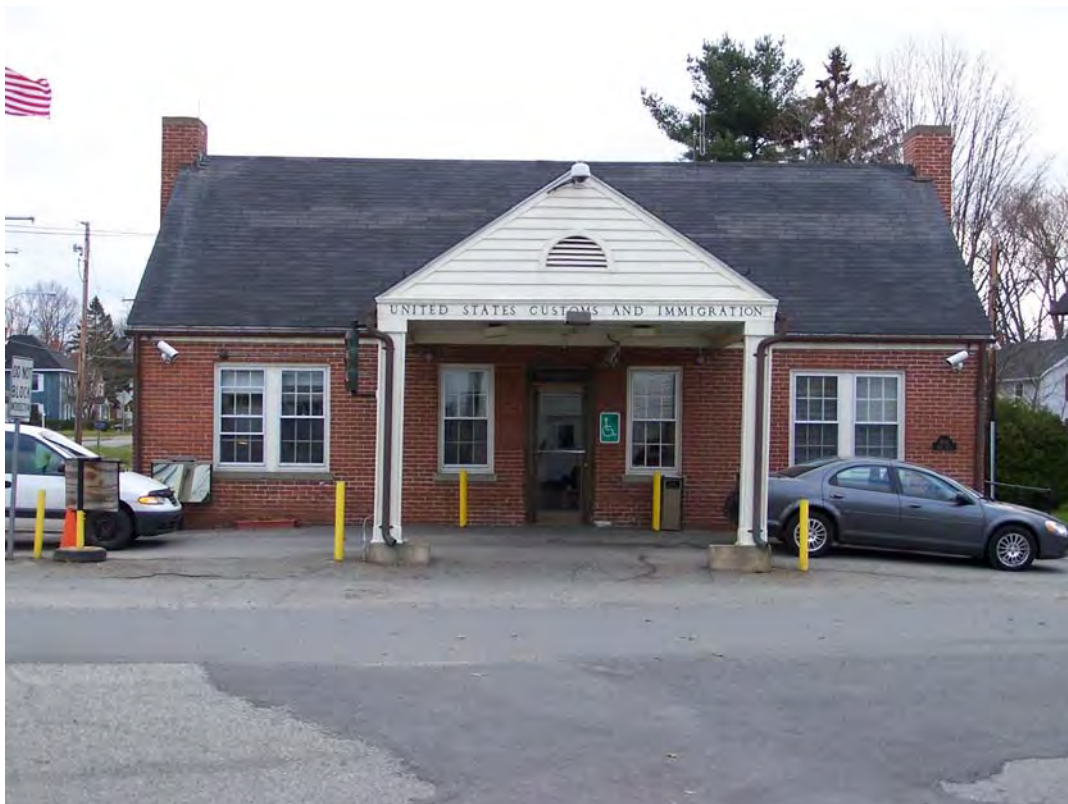
Photo number: VT_OrleansCounty_BeebePlainBorderStation1.tiff

Description of view: front elevation, view: east

The Beebe Plain Inspection Station possesses a variety of Colonial Revival design features. The complex 3-bay front elevation is highly symmetrical, and features a centered front entrance. The centrally located entrance bay consists of an aluminum frame single leaf storefront door that is a later, c.1960s era alteration. This door frame is of a similar stained aluminum and features a single transom window. This door is flanked closely on either side by 6/6 wood frame double hung sash windows inset into the wall with molded wood picture framing and underscored by exposed concrete sills. Each outer bay of the front elevation features a pairing of 6/6 woodframe windows with the same design treatment as the windows, except one continuous sill underscores each pair. A bronze aluminum rain gutter with floral patterned bronze bracketing is present at either end of the front elevation.

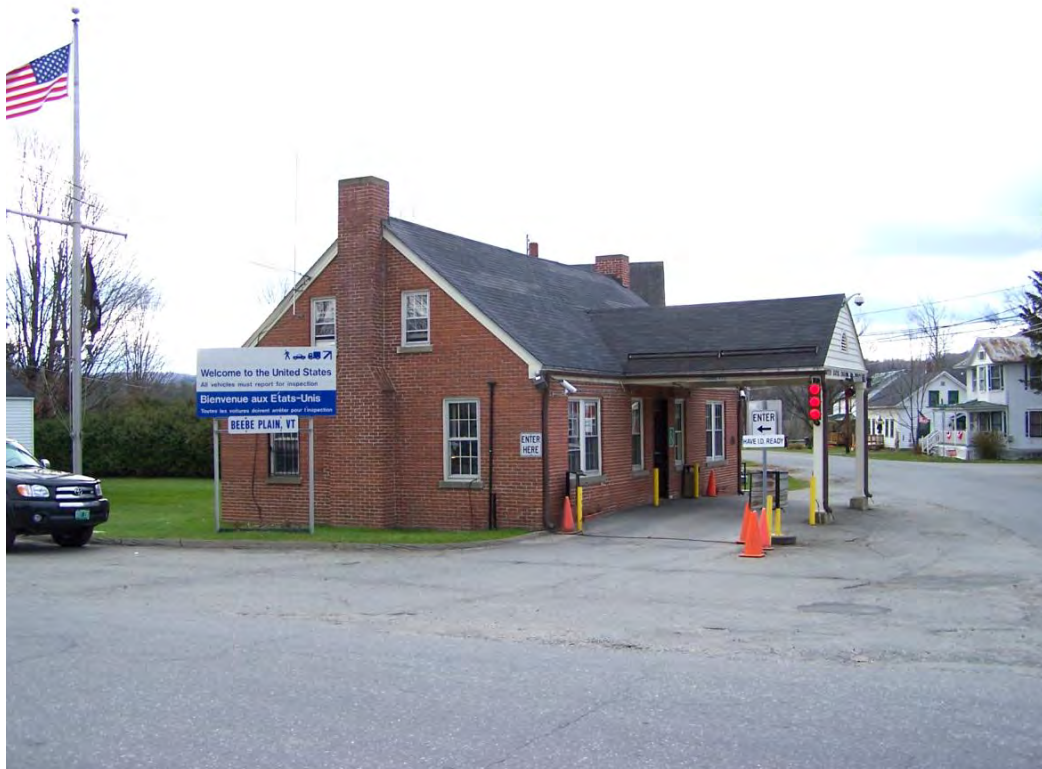
Photo number: VT_OrleansCounty_BeebePlainBorderStation2.tiff

Description of view: north (side) and front elevation, view: southwest

Windows that are 6/6 double hung sash and similar in scale and design features to those at the front elevation are symmetrically placed at the first level of each side elevation. The building features running course brick outside end chimneys at either side, and the southern of these is *faux*. The upper level of each side elevation features smaller scale 6/6 windows, identically treated as the others, placed adjacent to each side of the chimney. A plain fascia is present at each gable. The highly symmetrical rear elevation of the Beebe Plain Inspection Station is 4 bays wide with a 3-bay

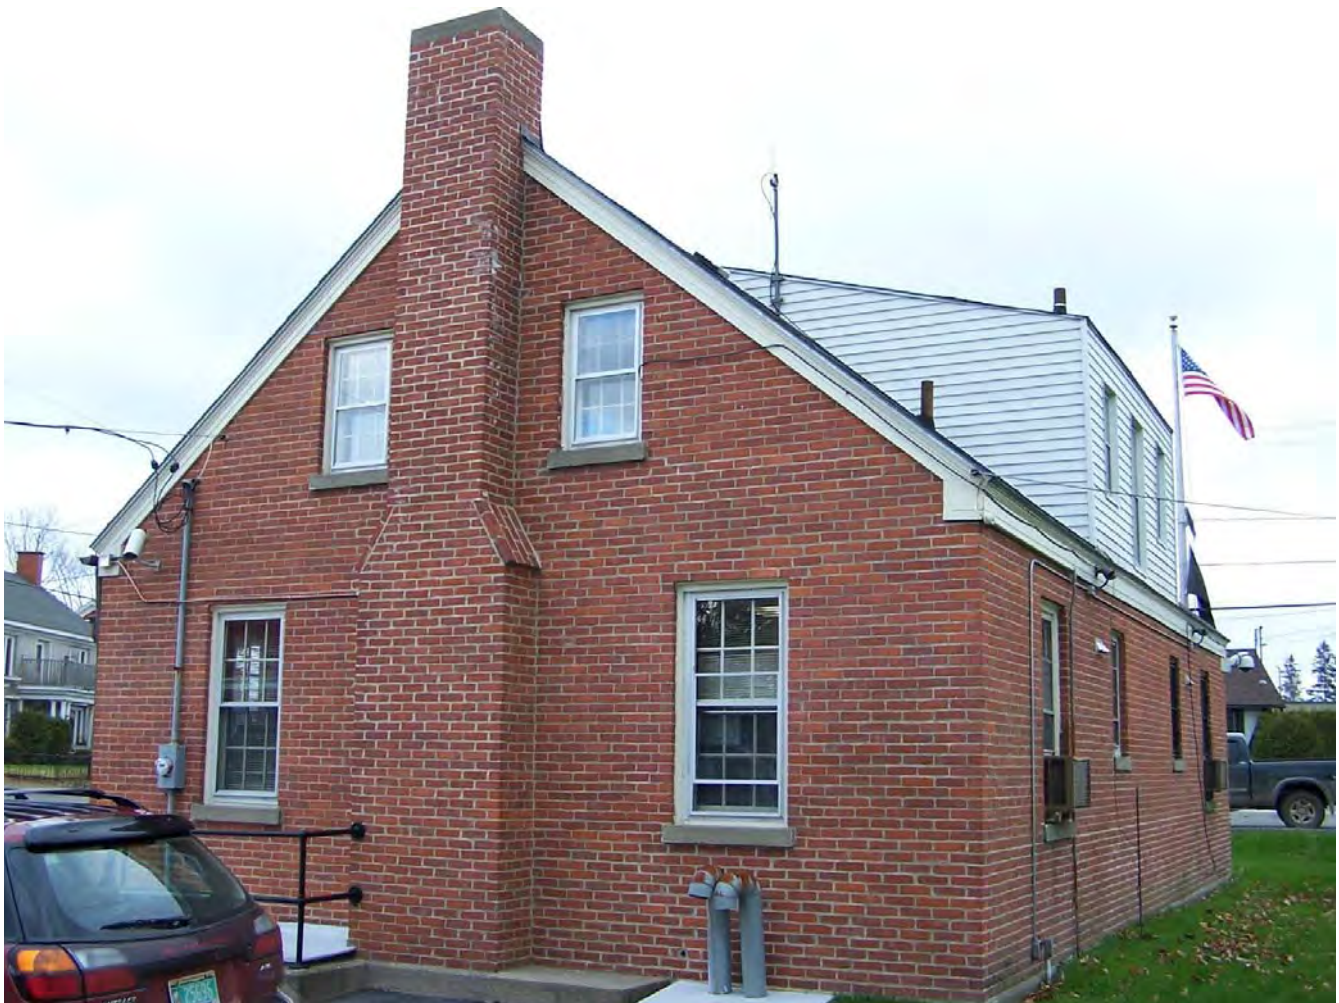
Photo number: VT_OrleansCounty_BeebePlainBorderStation3.tiff

Description of view: south (side) and east (rear) elevation, view: north

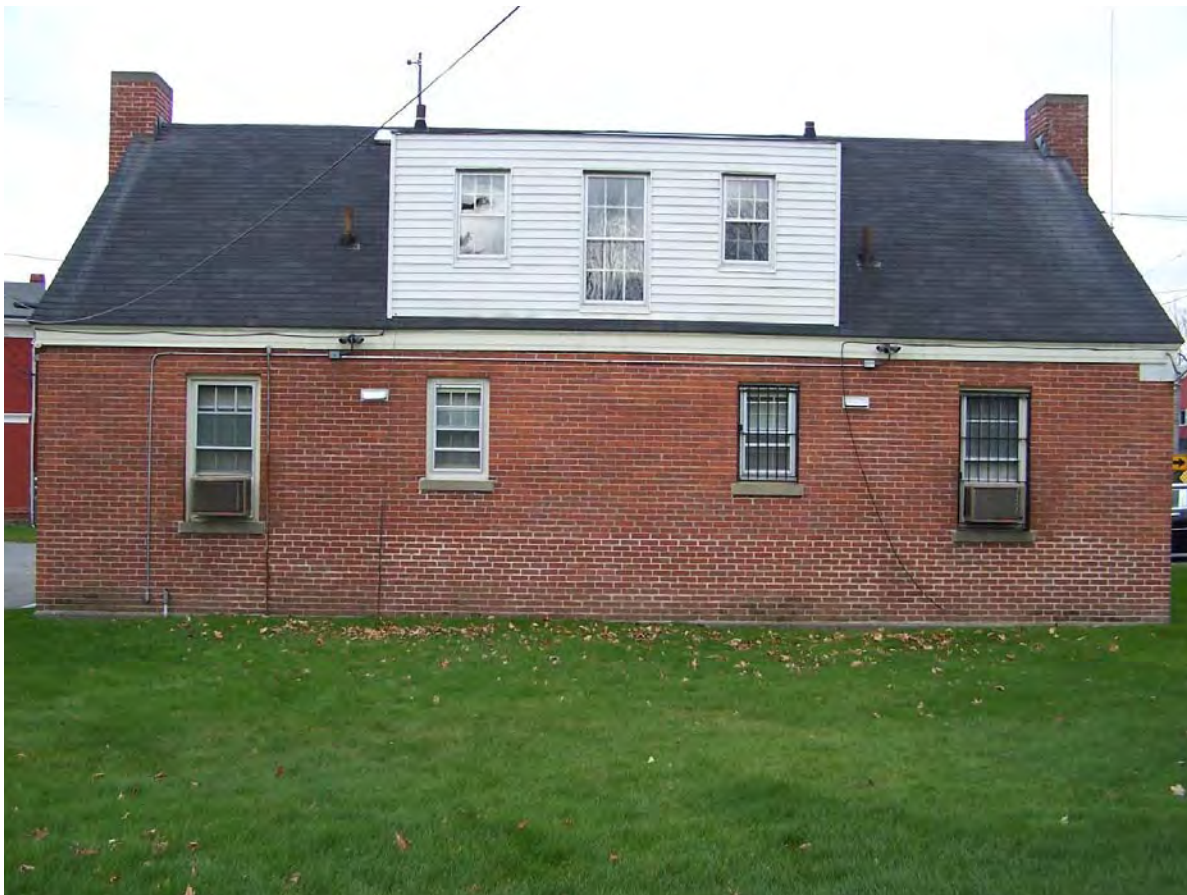
Photo number: VT_OrleansCounty_BeebePlainBorderStation4.tiff

Description of view: rear elevation, view: west

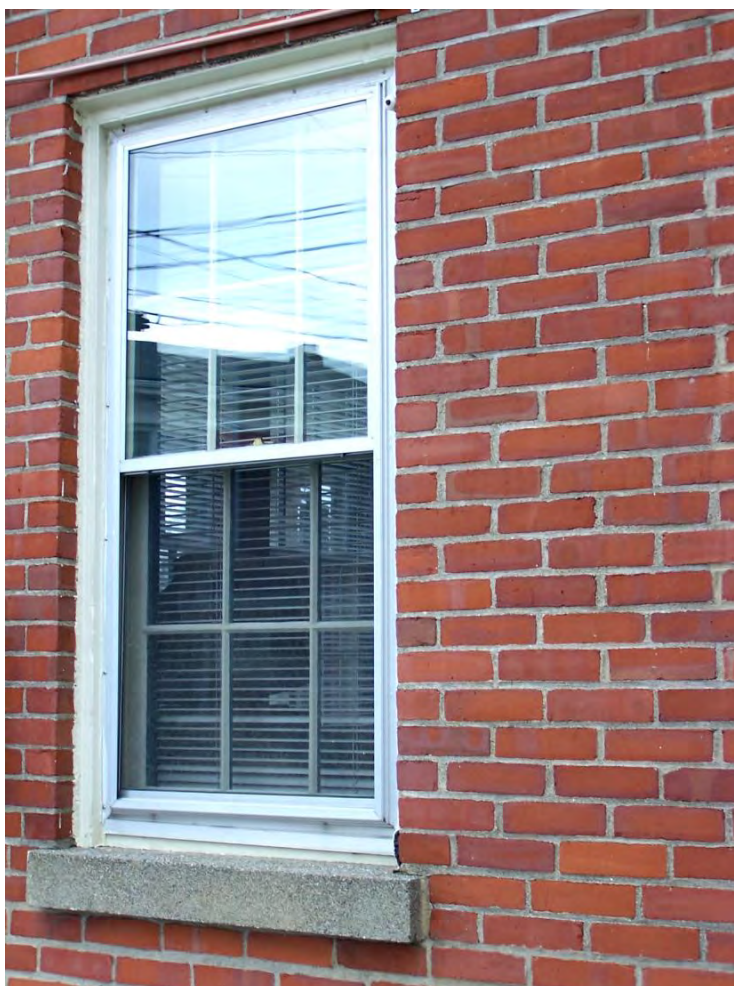
Photo number: VT_OrleansCounty_BeebePlainBorderStation5.tiff

Description of view: standard window, view: northwest

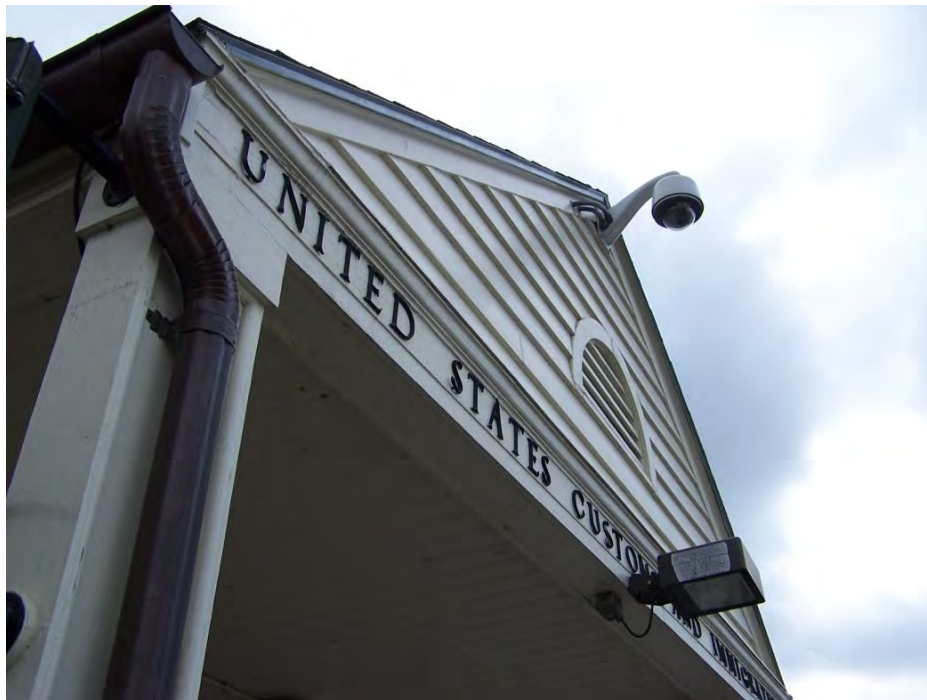
Photo number: VT_OrleansCounty_BeebePlainBorderStation6.tiff

Description of view: porte-cochere gable, view: southeast

The front gable of the porte-cochere is clad in wood clapboard, and centered within it is a lunette shaped vent. Both the gable and the vent are trimmed in wood. At the bottom portion of the gable is metal, Roman style, serif lettering spelling out "UNITED STATES CUSTOMS AND IMMIGRATION." Steel columns clad in paneled wood rectangular columns support the porte-cochere. Bronze rain gutters similarly detailed to those previously mentioned are placed upon each column. A mowed grass yard is present behind both the Inspection Station and the garage. A mast style metal flagpole with a balloon finial is located near the northwest corner of the property.

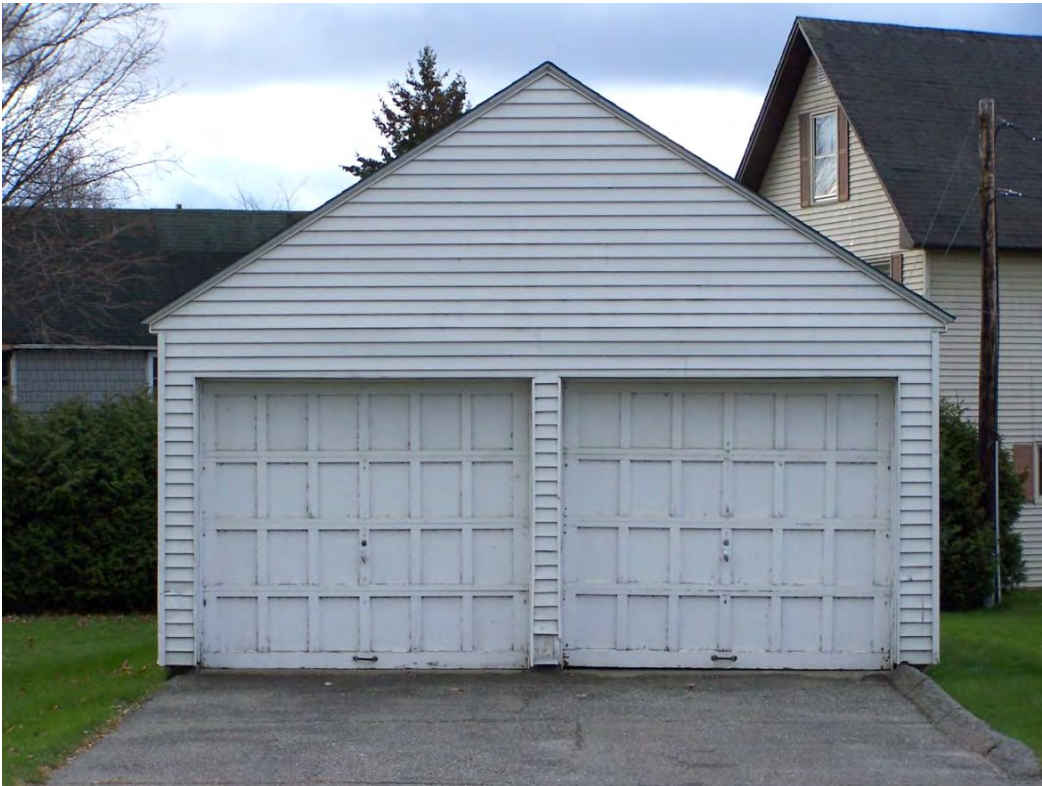
Photo number: VT_OrleansCounty_BeebePlainBorderStation7.tiff

Description of view: garage front elevation, view: south

A detached 2-bay automobile garage is located east of (behind) the inspection station building. The garage is clad in wood clapboard terminated with cornerboards. The roof of the garage is front gabled and is clad in asphalt shingle and is underscored with a fascia board at each side. The garage bay doors are multi-paneled wood. A 6/6 wood frame double hung window with wood trim is present in middle of each side elevation, and in the rear elevation.

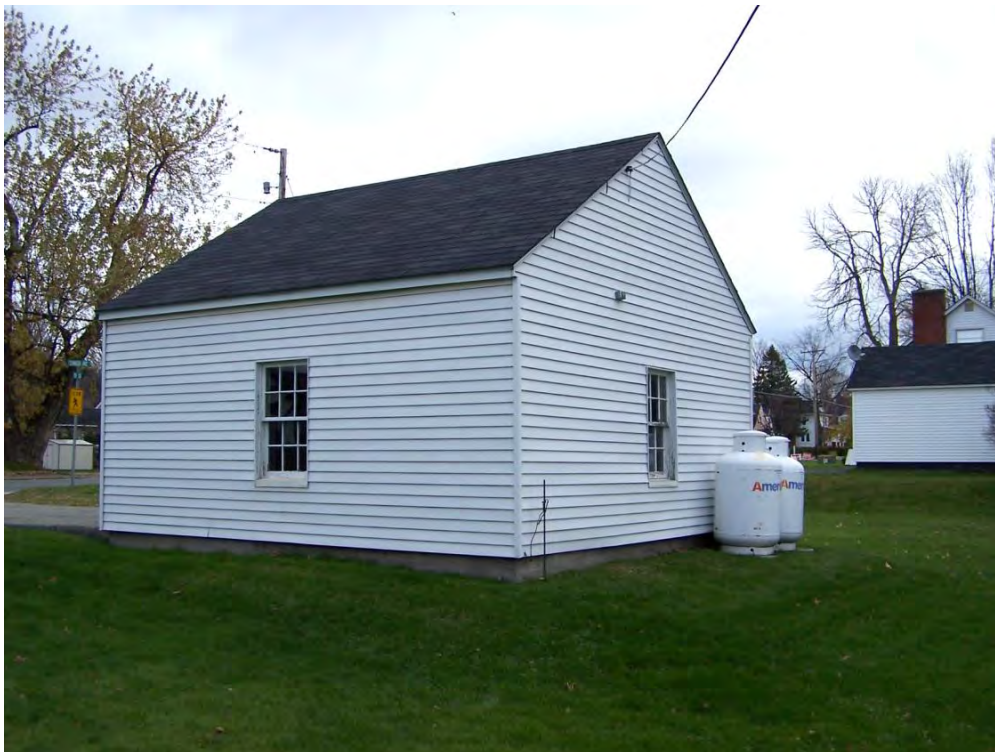
Photo number: VT_OrleansCounty_BeebePlainBorderStation8.tiff

Description of view: garage west (side) and rear elevation, view: northeast

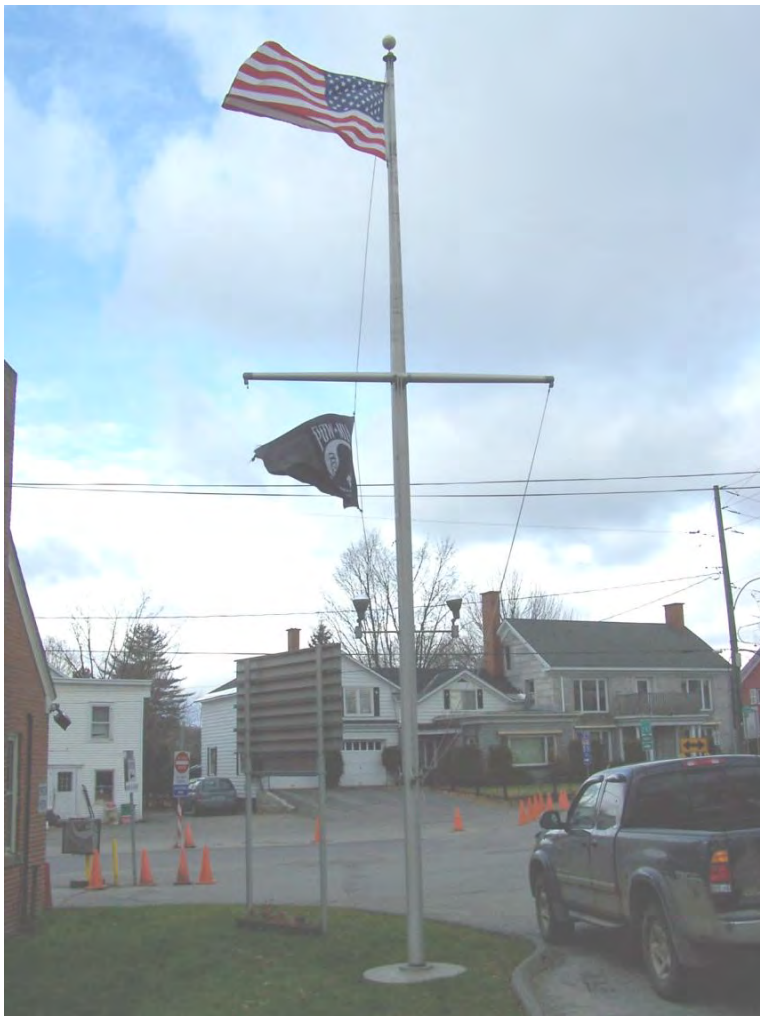
Photo number: VT_OrleansCounty_BeebePlainBorderStation9.tiff

Description of view: flagpole, view: west/northwest

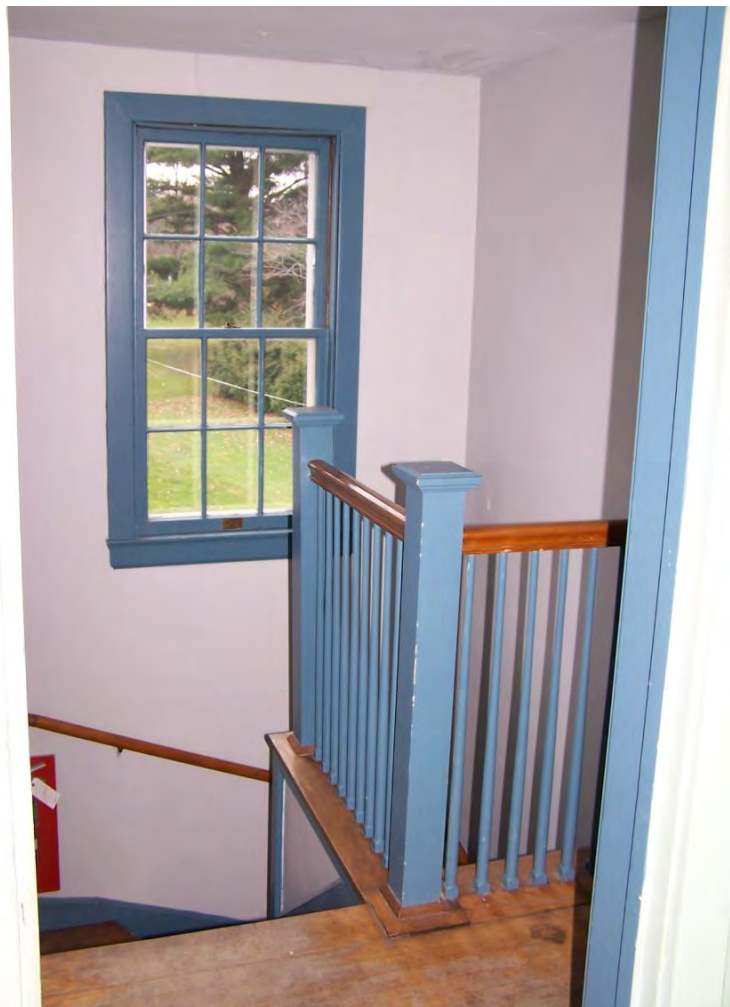
Photo number: VT_OrleansCounty_BeebePlainBorderStation11.tiff

Description of view: stairwell, view: east

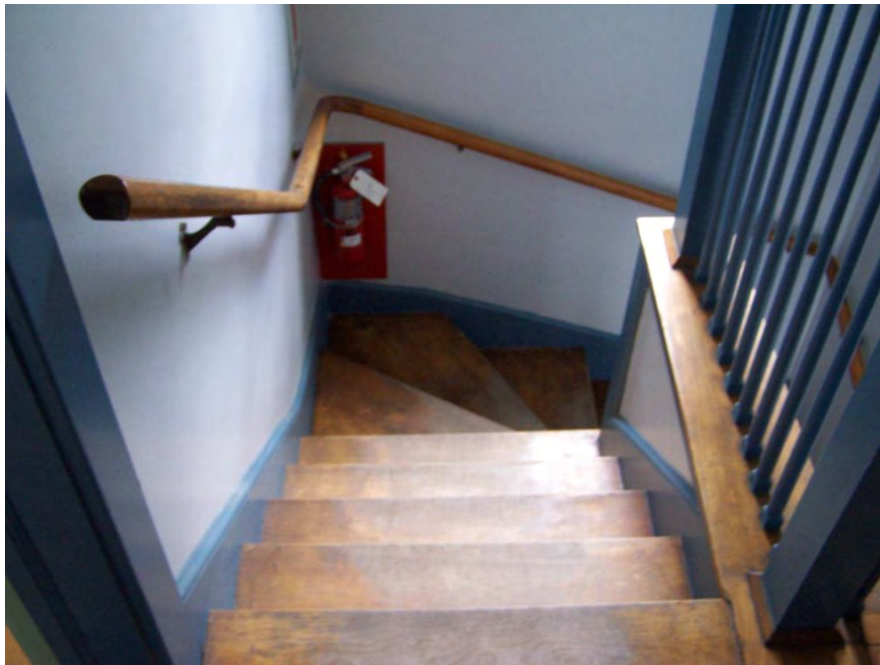
Photo number: VT_OrleansCounty_BeebePlainBorderStation12.tiff

Description of view: stairwell view: east

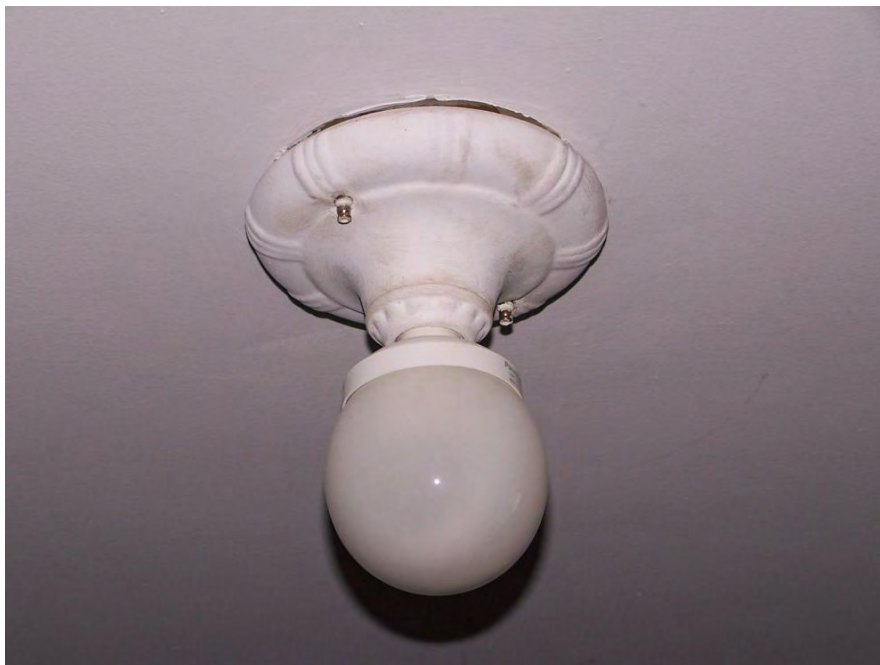
Photo number: VT_OrleansCounty_BeebePlainBorderStation14.tiff

Description of view: original light fixture, second floor, view: south

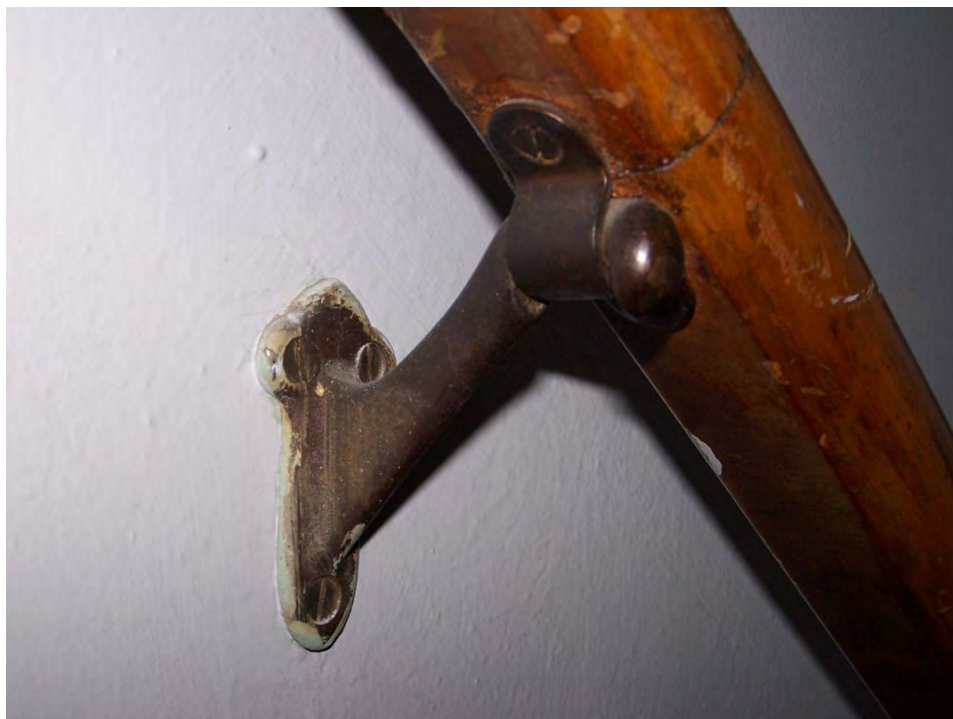
Photo number: VT_OrleansCounty_ BeebePlainBorderStation15.tiff

Description of view: rail bracket, stairwell, view: northwest

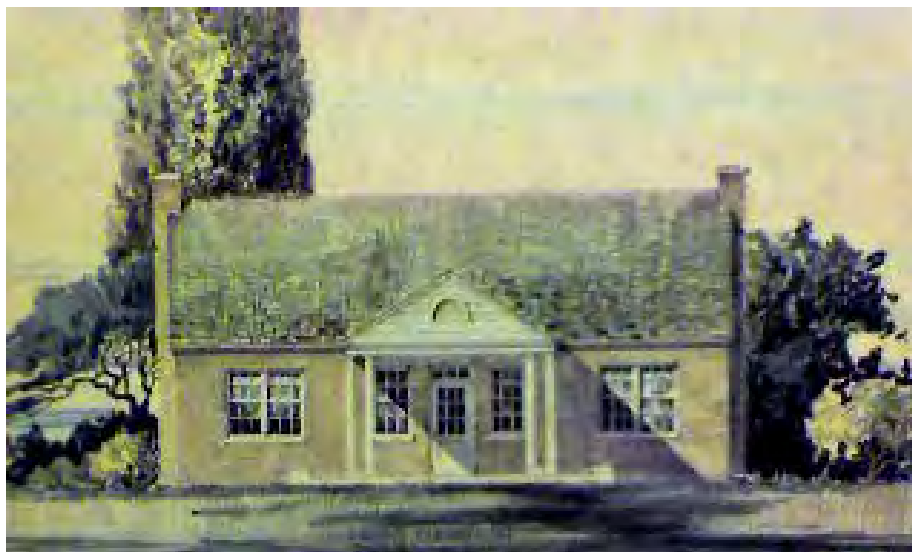
Date: 1936

Description of view: front elevation

The renderings for the U.S. Inspection Stations are found at the National Archives and Records Administration (NARA). The U.S. Inspection Station--Beebe Plain shares an identical set of plans with the Sasabe, Arizona U.S. Inspection Station. Compared to many other Inspection Stations from the Public Works Administration (PWA) era, the details on the Beebe Plain building are relatively sparse, and of inexpensive materials. According to the General Services Administration, this may have been because these designs were completed in the midst of the Great Depression.⁴ The U.S. Inspection Station--Beebe Plain continues to possess many features originally depicted in the front elevation rendering. Aside from the replacement of the entry door and its transom, the U.S. Inspection Station--Beebe Plain as extant looks remarkably similar to its original rendering.⁵
